**NBSIR 76-1025**

# **Air-Mobility Rigid Shelter Systems**

An Interim Report

Prepared for  
**Air Force Civil Engineering Center**  
**Tyndall Air Force Base, Florida 32401**

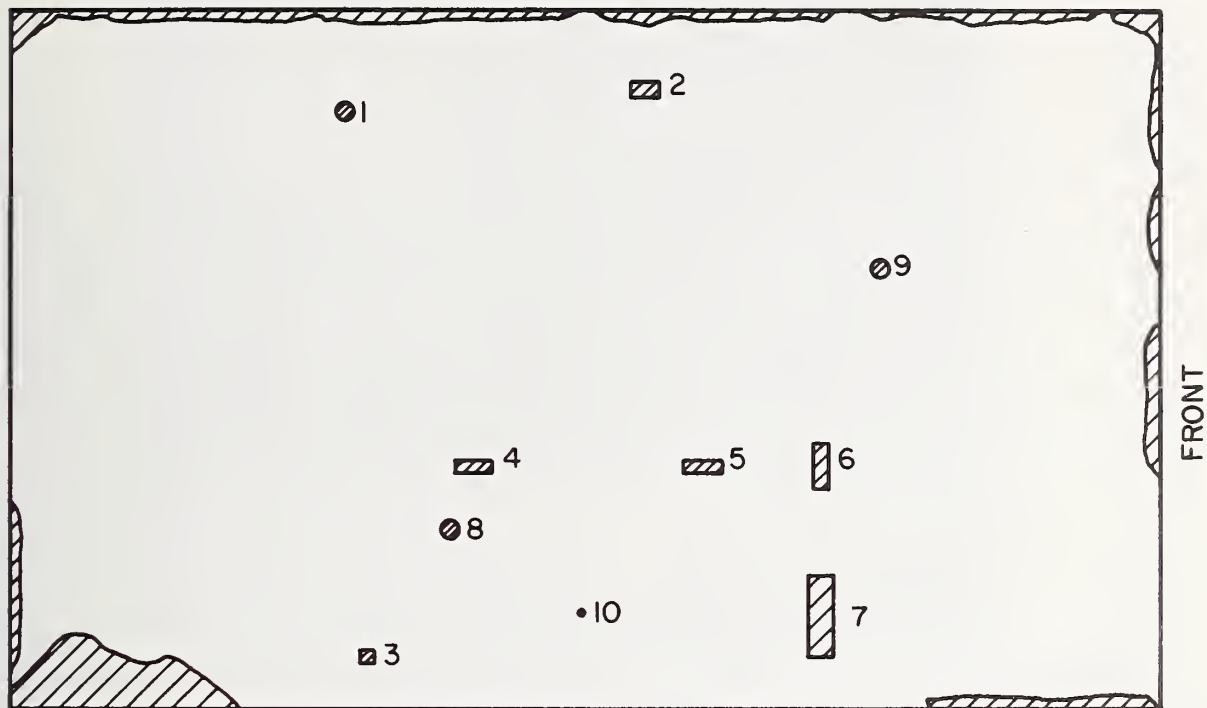
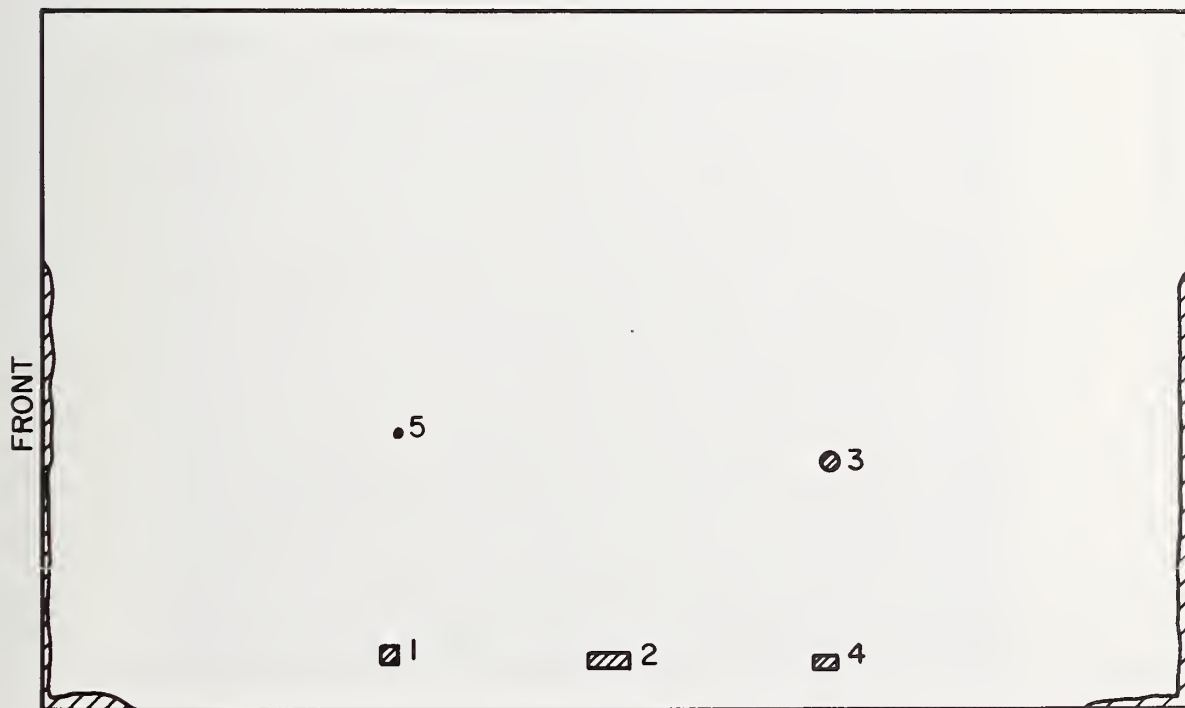
Fig. 2.15 Indentations and Delaminations,  
EXP Shelter 285

Table 2.2 is a listing of the indentations and damaged areas found on units 285 and 267. Locations of these areas and delaminations are indicated in figures 2.15 and 2.16. The panel "names" given to the individual panels are those used by the field personnel. "Interior floor" panel means the fold-down floor panel which is closest to the center structure when the shelter is expanded. These two shelters were the outside (285) and middle (267) units of a three shelter assembly (see figure 2.2a). The most indentations occurred on the fold-down floor panel (interior or inboard floor panel when expanded) that is exposed to weathering during storage. Of all the indentations measured on the panels of both shelters, only one was deeper than 1/8 in. Three indentations were found on shelter 267, but with only one being of any consequence. The indentation at location 2 of 267 appeared to be caused by the fork of a lift truck. It was located adjacent to a designated lift point. The location of this indentation was such that measurement with available instrumentation was not possible but the estimated depth was about 1/4 in. Figure 2.17 is a photograph of a similar indentation from a lift-truck fork, but was in the front-end wall.

The most extensive delaminations were found about the periphery of the exterior facing of the left fold-down floor panel on the outside unit (No. 285). This is the facing that was exposed to weathering during storage. Over 60% of the length of the outside edge was delaminated approximately 1 to 2 inches in from where the aluminum skin was attached to the edge members. Of the panels protected during storage, the exterior facing of the right fold-down floor section of No. 285 was delaminated about 29% of the length of the edge.

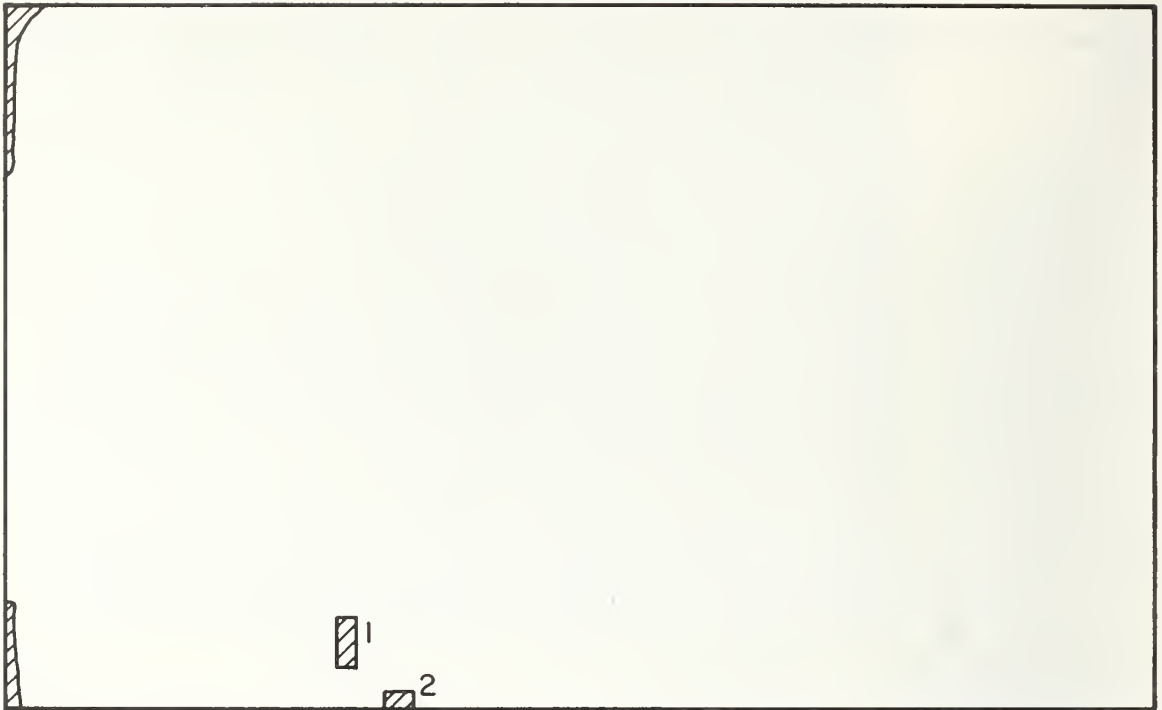
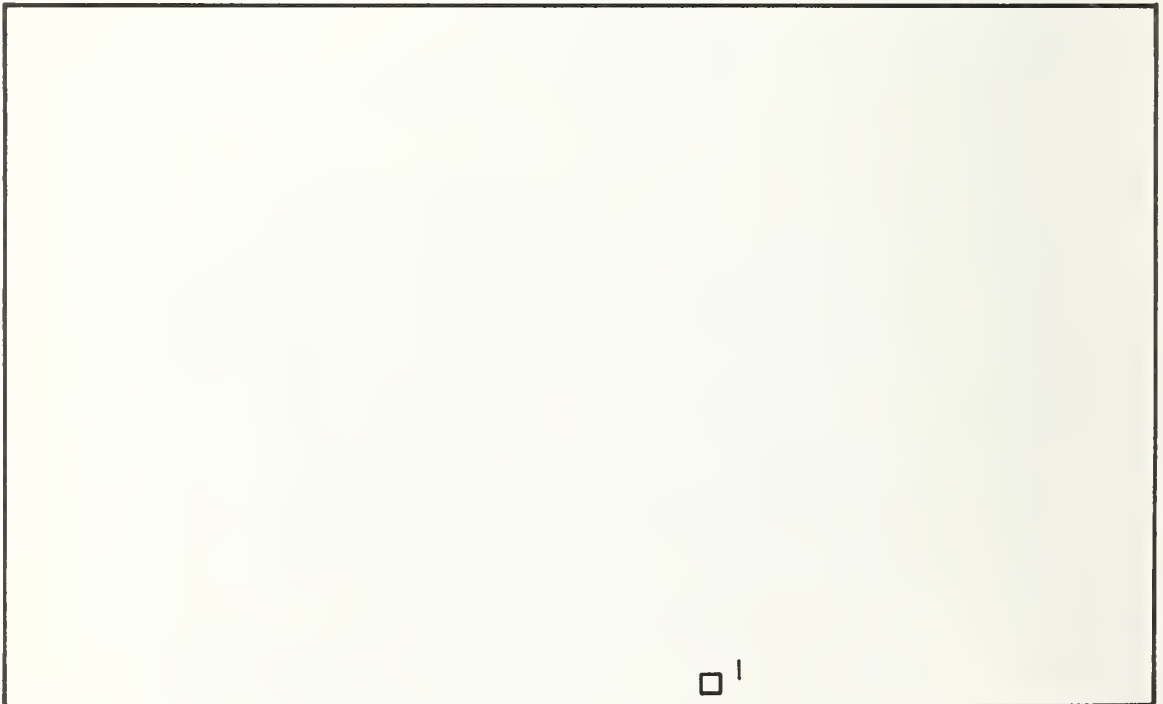
Fig. 2.16 Indentations and Delaminations,  
EXP Shelter 267

The edges of the fold-down panels of shelter No. 267 (the center unit of the three shelter assembly) were delaminated for only 8% of the length on the left panel and none was found on the right panel. Figures 2.15 and 2.16 are scale drawings of the exterior facing of the fold-down floor panels for the two shelters and show the location of the indentations and the delaminated areas. No delaminations were found on any other panels in this shelter. No large areas of delaminations were found on the panels of these two shelters such as were observed on some other stored EXP's (see figure 2.19).

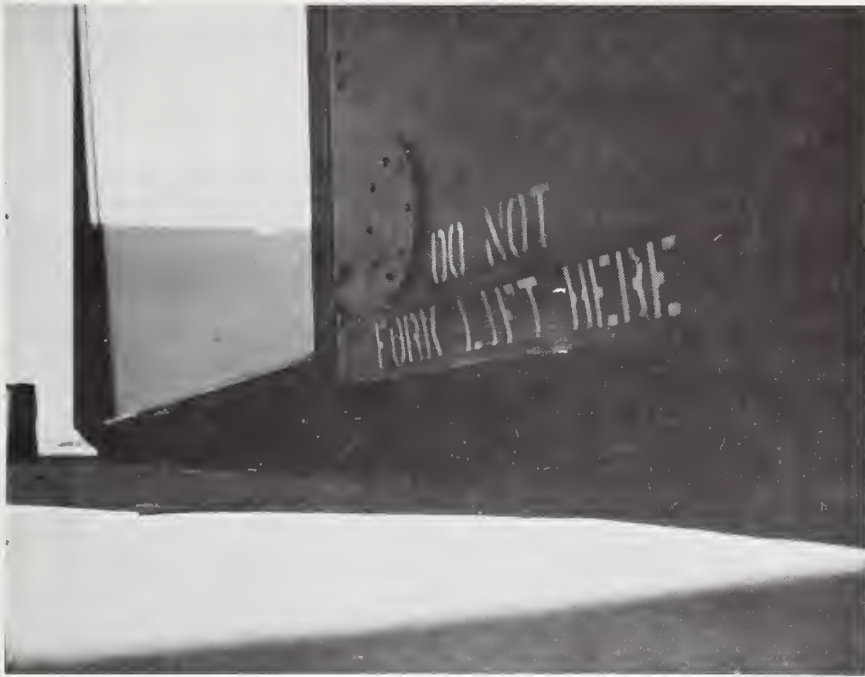
Fig. 2.17 Lift Truck Fork Damage

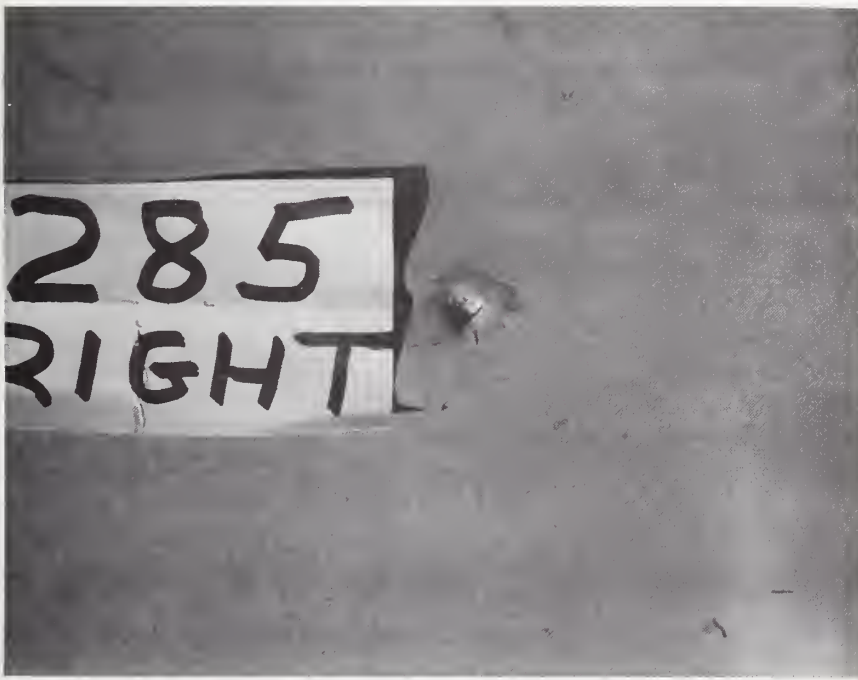
One puncture failure was found on the interior facing the fold-down panel of shelter 285. This penetration was triangular in shape and can be seen in Figure 2.18. A pencil probe inserted into the puncture extended all the way through the panel to the inside of the exterior facing.

Fig. 2.18 Puncture Damage, Floor Panel of EXP

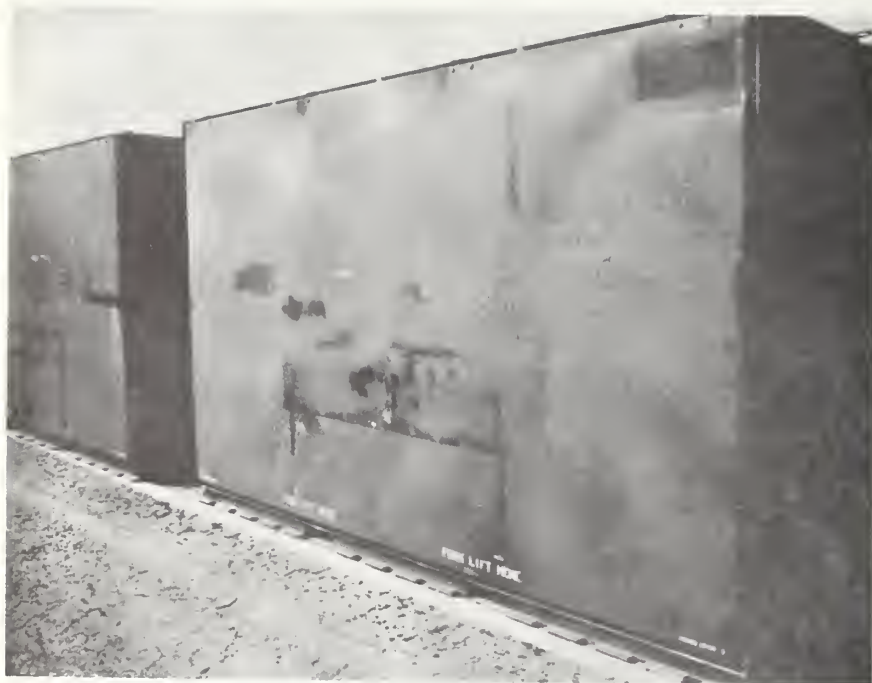
Fig. 2.19 Extensive Delamination of Interior Floor Panel of Stored EXP

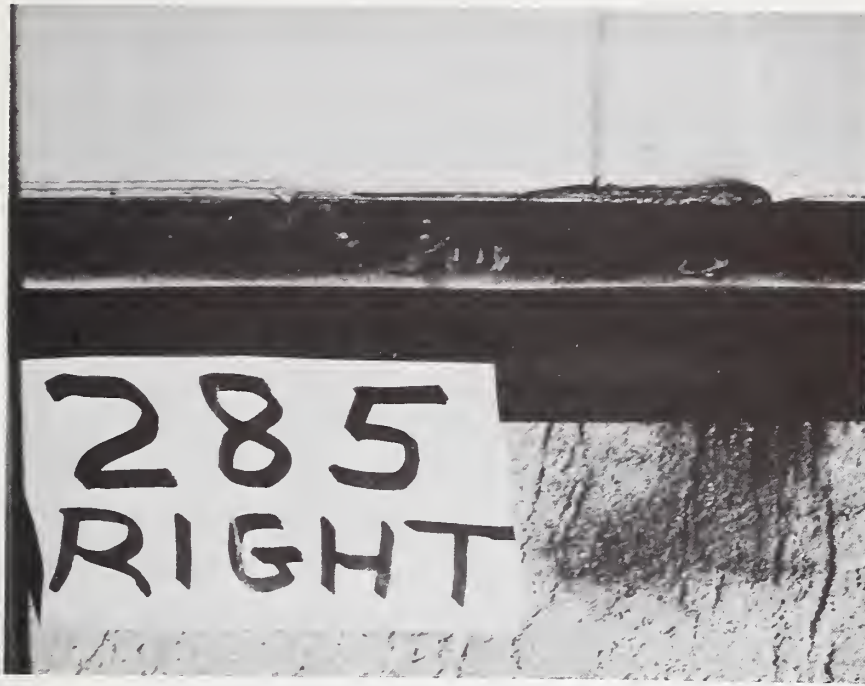
Figure 2.20 is a photograph of water leakage from the fold-down floor of shelter No. 285. No evidence of this leakage was apparent on the shelter while it was in the stored position, but when the shelter was opened for inspection of the interior surfaces, water ran from the delaminated edge of this floor panel. A pool of water approximately 8 inches in diameter resulted and the leakage continued for about an hour. Figure 2.21 shows a brown colored residue of leakage similar to that observed on several shelters that were in the storage area. In general, this staining was observed at the outer edge of the mid-height joint in the facing of the exposed floor panels (figure 2.22). (Weather side during storage). Figure 2.23 is a photograph of visible water seeping from a puncture in the skin of the fold-down floor panel of a stored EXP.

Fig. 2.20 Water Leakage at Mid-span Seam of Interior Floor Panel, EXP 285

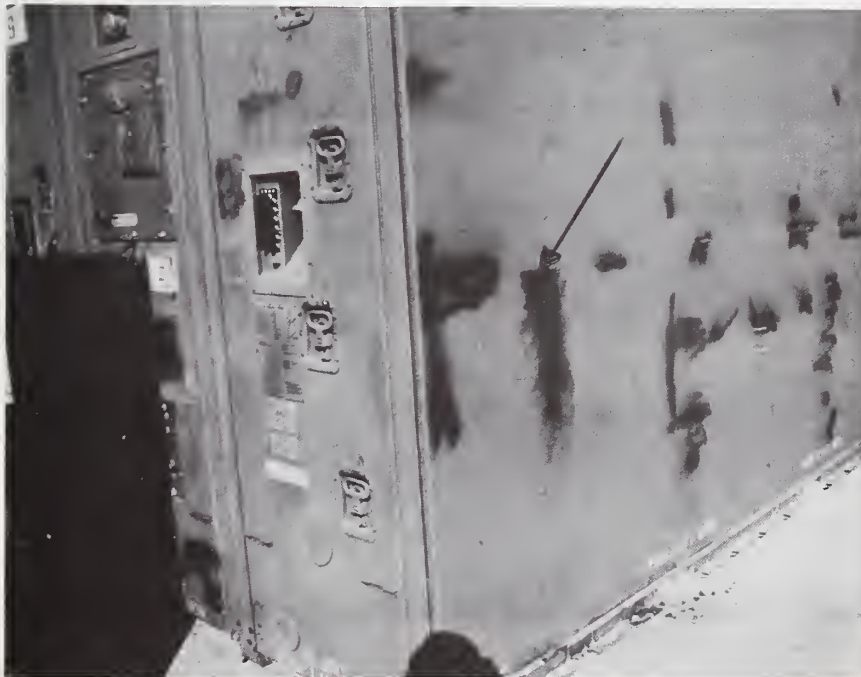
Fig. 2.21 Brown Leakage Stain Emanating from Mid-plane Joint of EXP

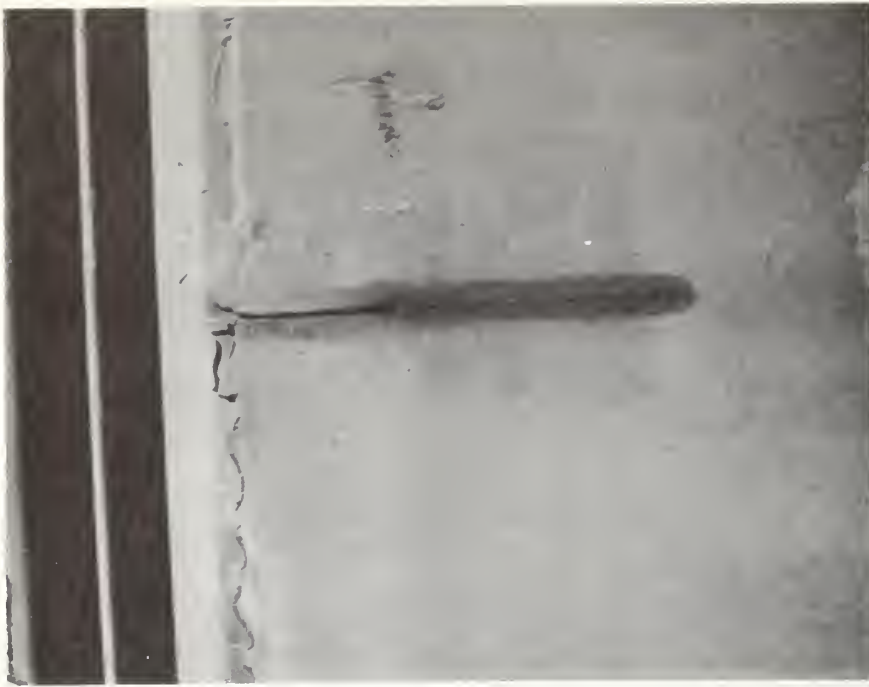
Fig. 2.22 Leakage Stain at Mid-plane Joint Near Edge of EXP

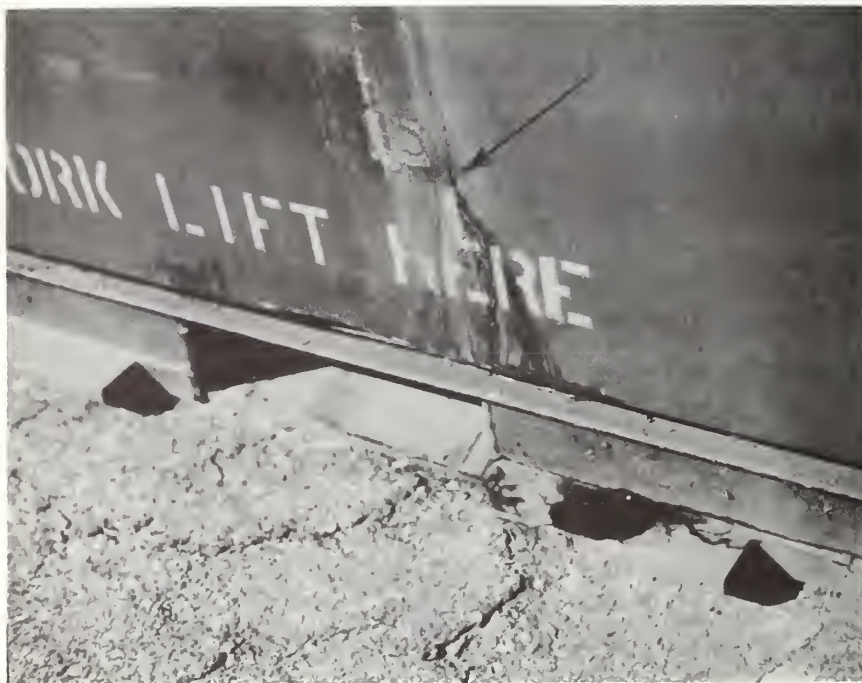
Fig. 2.23 Visible Water Leakage at Puncture in Facing of EXP

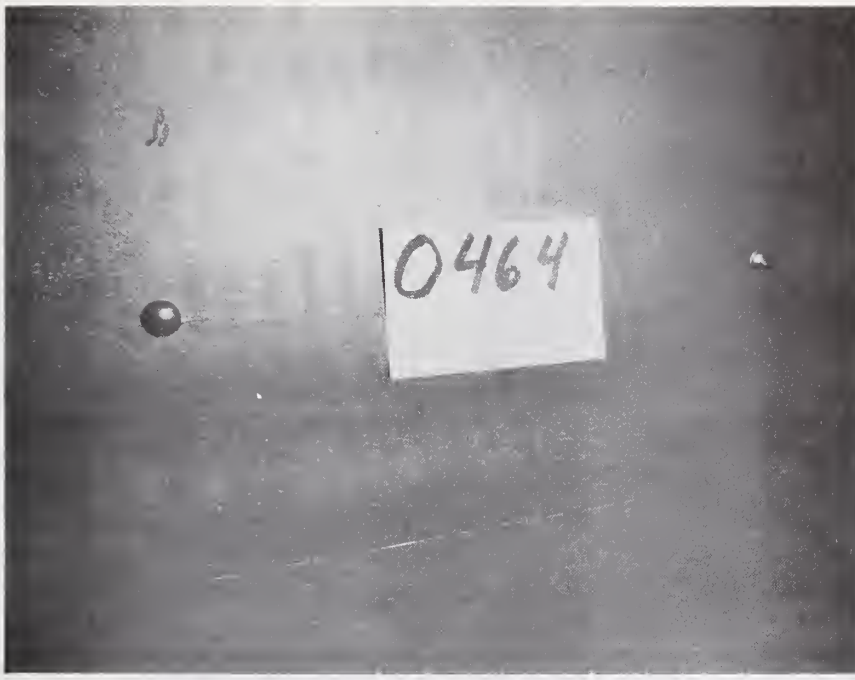
Two minor fabrication flaws, that had not been observed on the old ones, were observed on the new EXP's. These flaws were the result of the design change in the new shelters. The fabric floor covering had several blisters approximately 1/2 to 3/4 in diameter in the surface as seen in figure 2.24. These blisters appeared to be of air probably entrapped during the manufacturing process. The blisters were probed to determine if any liquid was present, but none was found.

Fig. 2.24 Blisters in Floor Covering Material  
- New EXP

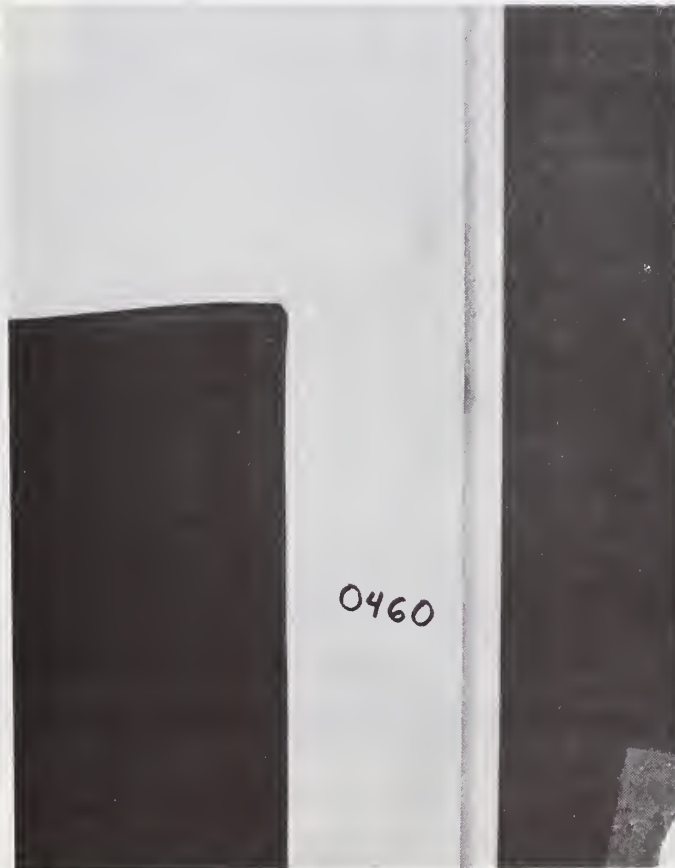
The other flaw noticed was a black discoloration of the white finish on the interior of the exterior end wall of shelter No. 0464. This dark discoloration is visible in figure 2.25. It was not possible to determine what this discoloration is or how it became prominent. The discoloration appeared to be within the finished surface and was not water staining or fungus growth on the surface.

Fig. 2.25 Discoloration on Interior Wall Panels  
- New EXP

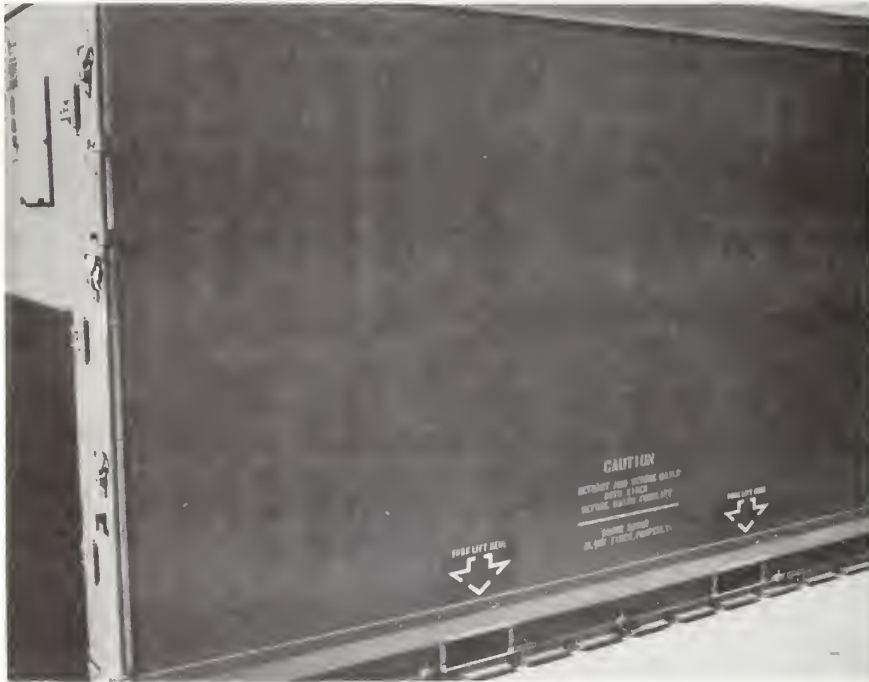
The reason that these two shelters were chosen for close inspection is that their fold-down floor panels were good examples of two conditions which were common to most of the newer ES/C's. At some places in a panel the facing between the internal beams was depressed below the level of the beams while, at other places the facing was bulged above the beam level (figure 2.28). The occurrence of these two conditions in the same panel seems to indicate that lack of foam-thickness tolerances during fabrication may be the cause.

In general, it can be said that, of the two conditions noted above, bulging of the facing is the dominant condition. For this reason it seems likely that foam-growth, sometimes exhibited in foam panels, is the primary factor in the out-of-planeness.

Fig. 2.28 Bulging of Foam and Beam Floor Panels  
- Newer ESC

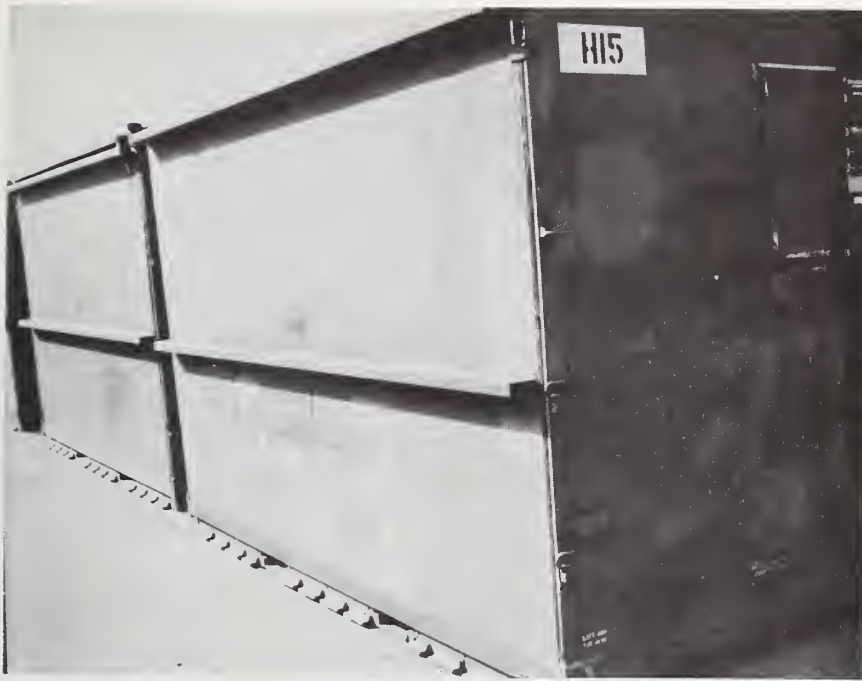
The greatest single defect observed during the inspections of the old ES/C's was delamination of the aluminum skin from the foam core material. The delaminations observed were on the exterior of the fold-down floor panels that serve as side walls during storage. The extent of the delaminations varied from slight to almost complete. For examples of delaminated areas in old ES/C's see figure 2.3a and also figure 2.26.

Fig. 2.26 Delaminations in Fold-down Floor Panel - Old ESC

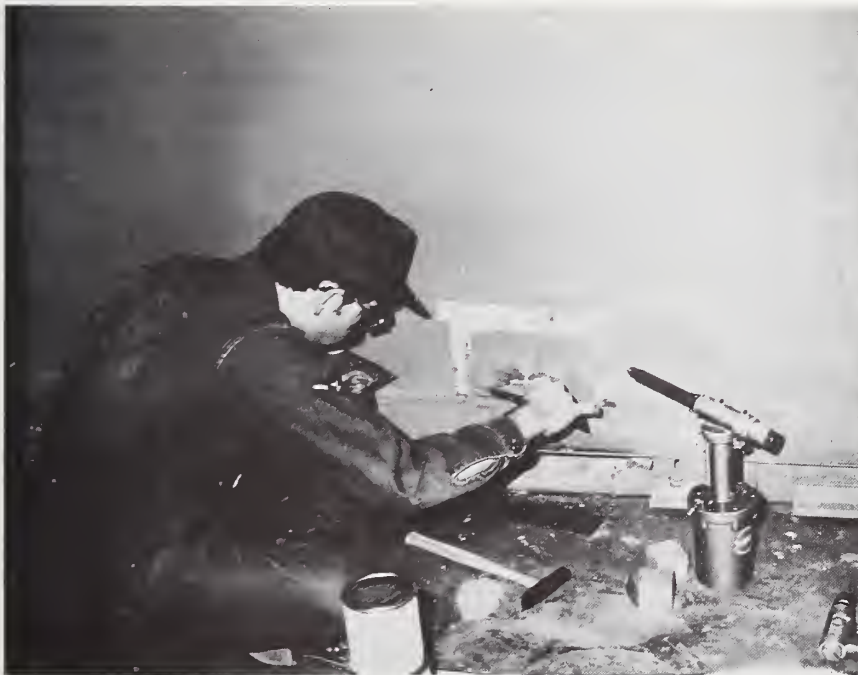
1. The treated fabric weatherstrip closure over the roof panel hinge (figure 2.3a and 2.3b) on every ES/C shelter examined, had shrunk to the point where none of them could be properly closed to protect the hinge area from the weather.
2. All of the older shelters had indentations, mostly in the areas of lift-truck pickup points. None of the indentations is considered to be directly contributory to the extensive delaminations observed.
3. Extensive and varied repair procedures were observed on many shelters. Some of the repairs appeared to be field expedients. Figure 2.27 shows shop repairs being made at a fork-lift damaged area.

Fig. 2.27 Repair Being Made at Fork-lift Damage Point

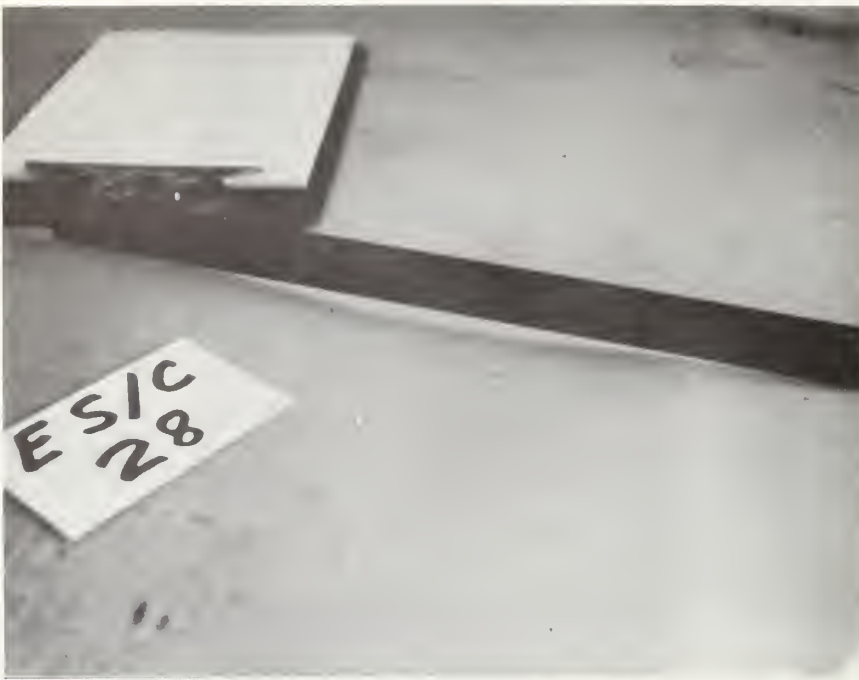
However, the floor panels that exhibited these conditions on the exterior were also distorted on the interior of the panel. On three of the four interior floor panels inspected, bulging of the facings was evident. Figures 2.29a and 2.29b depict the general magnitude of these bulging surfaces. Accurate measuring devices to profile the surfaces of the floor sections were not available but bulging as much as 3/4 inch out of the intended plane was noted.

Fig. 2.29 Bulging of Interior Facing on Foam and Beam Floor Panels - Newer ESC

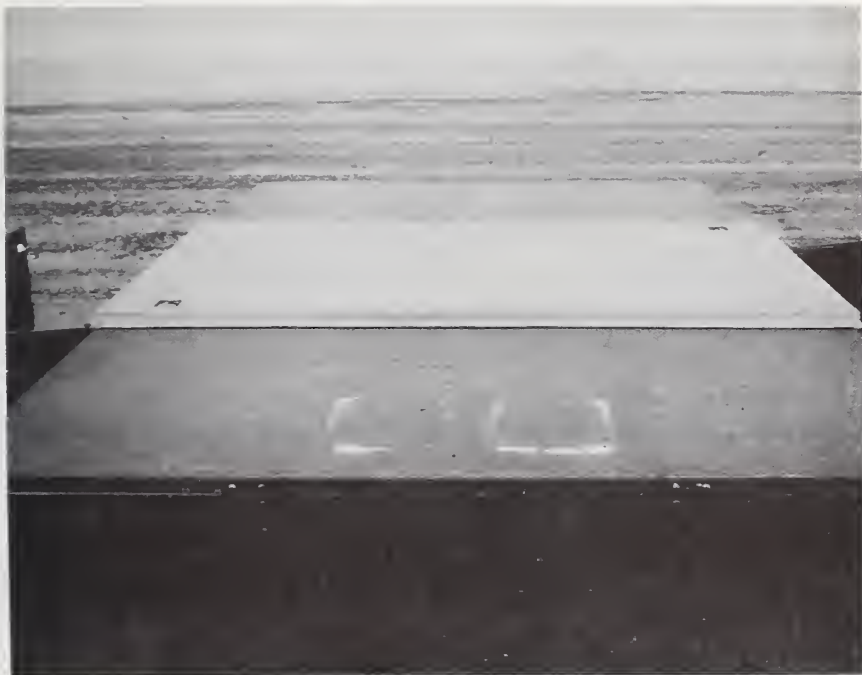
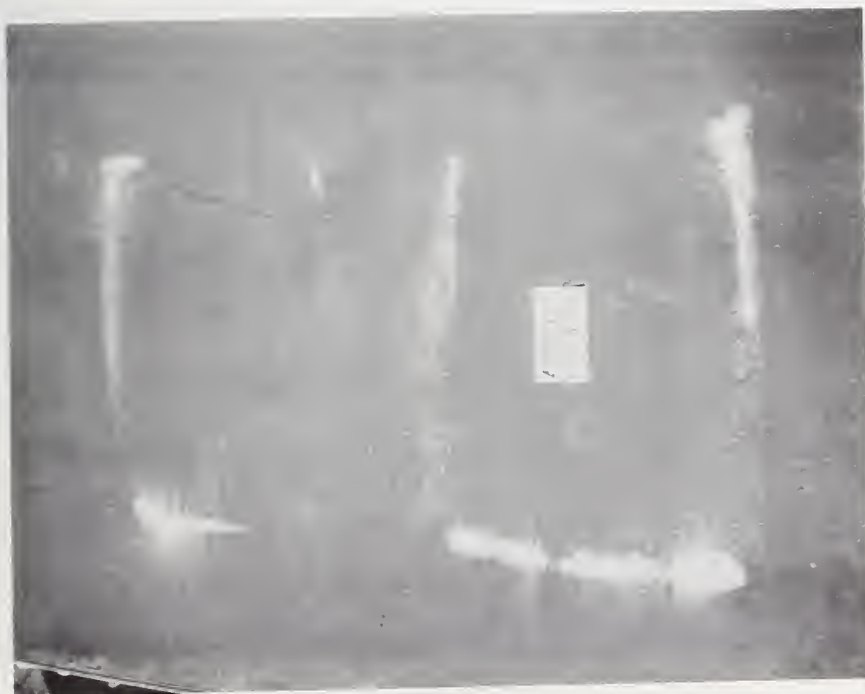
Fig. 2.30 Paint Deposits on Roof Panel of Newer ESC

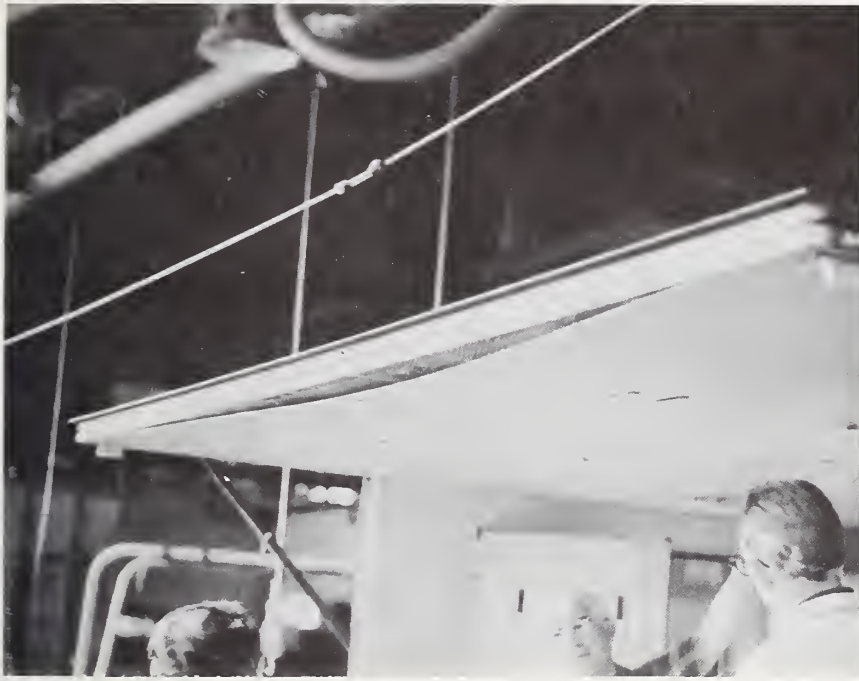
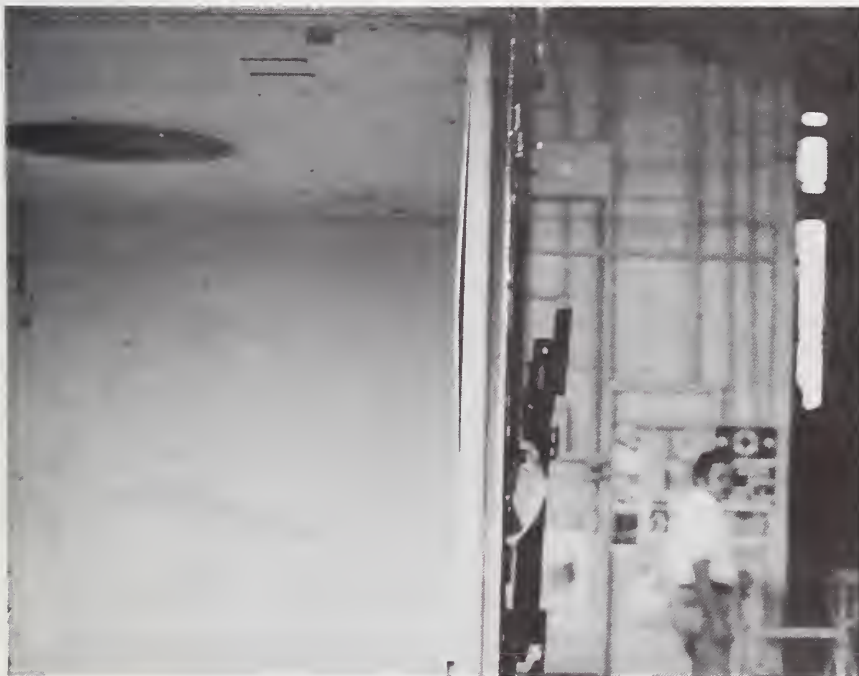
These shelters were made from honeycomb panels and many panels had delaminations (figure 2.32) which made the shelters unusable for their purpose. All of the MUST shelters inspected appeared to be well-used and were about 5 years old. There were punctures in the facings of some panels, predominantly in floor panels (figure 2.33), but no correlation between these punctures and delaminations could be found. In fact, the punctured panel of figure 2.33 was not delaminated. It should be noted that punctures are normally repaired by field personnel and it is possible that the delaminated panels did have punctures at some time.

No conclusions were reached in attempting to assess probable reasons for delamination of the honeycomb panels in these shelters. The fact that all the MUST shelters inspected were made by the same manufacturer and at about the same time, appears to cancel substandard fabrication facilities as a basic fault. Although it was stated that all delaminated panels which were repaired had water in them, it is not known if all delaminated panels have water in them or if all good panels are dry. However, it is reasonable to assume that design loads can induce delamination of wet panels, because the strength and stiffness of the paper honeycomb is greatly reduced when it becomes wet. In addition, degradation of the adhesive bond can be accelerated in the presence of moisture.

Fig. 2.32 Delamination of Honeycomb Panels  
- MUST Shelters

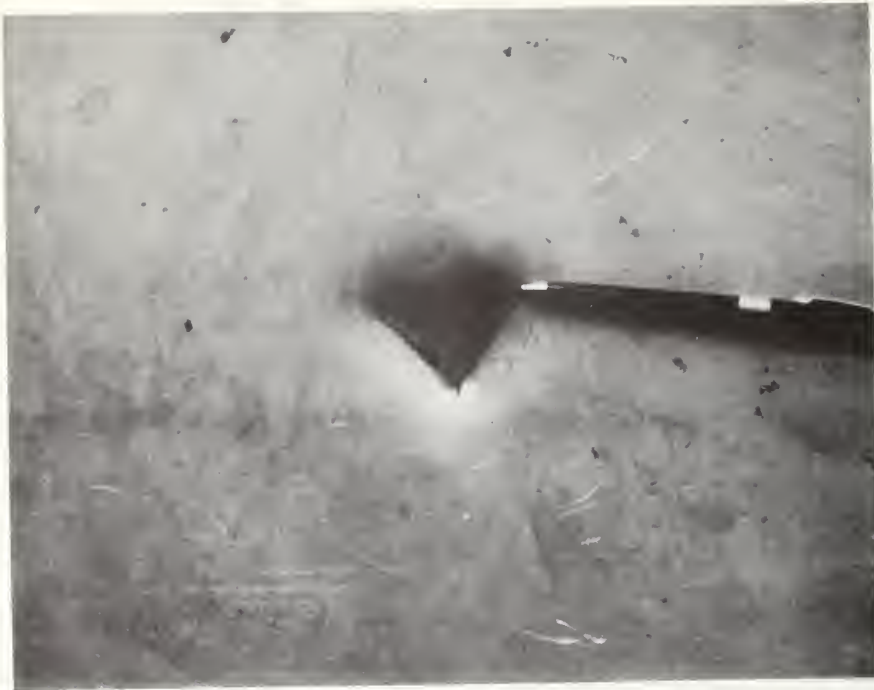
Fig. 2.33 Puncture in Floor Panel of MUST Shelter

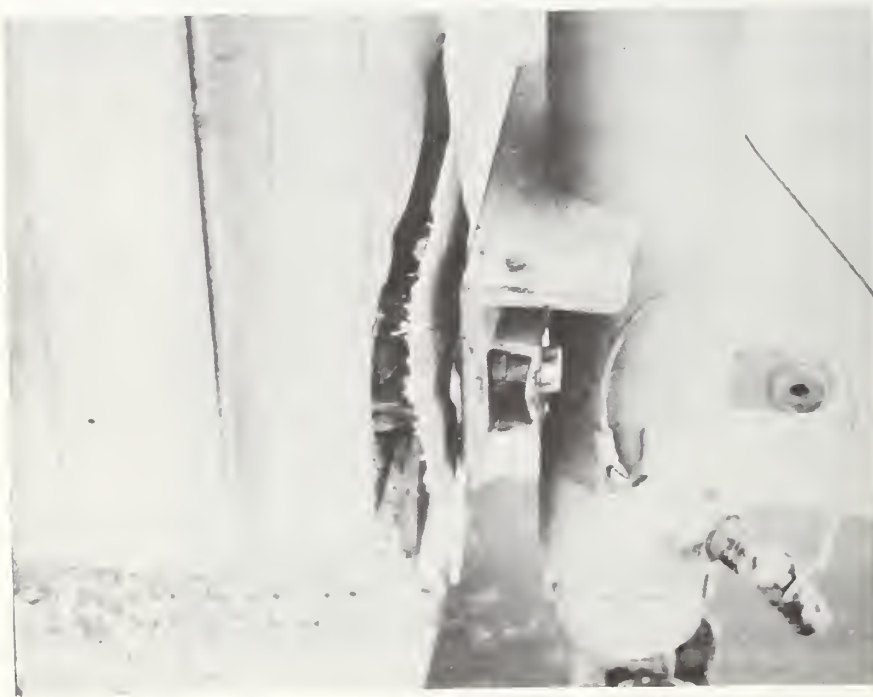
Fig. 2.34 Jacking Bracket Failure of MUST Shelter

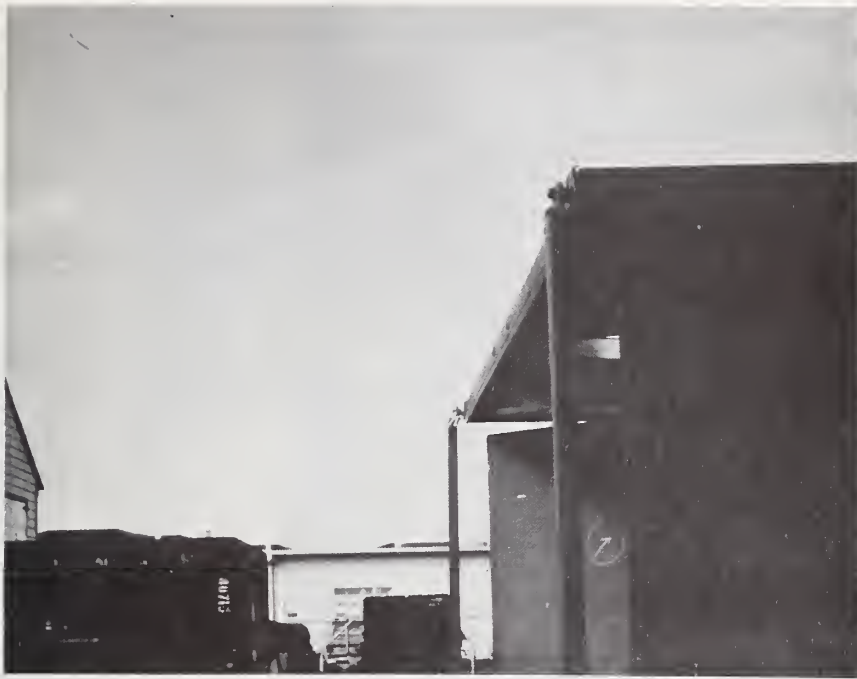
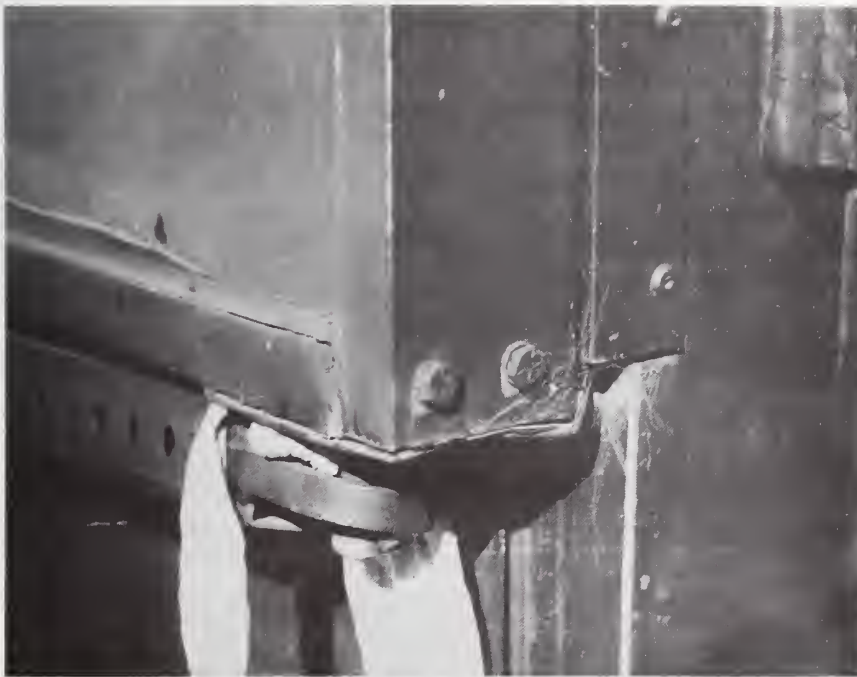
Fig. 2.35 Roof Support Bracket Failure of MUST Shelters

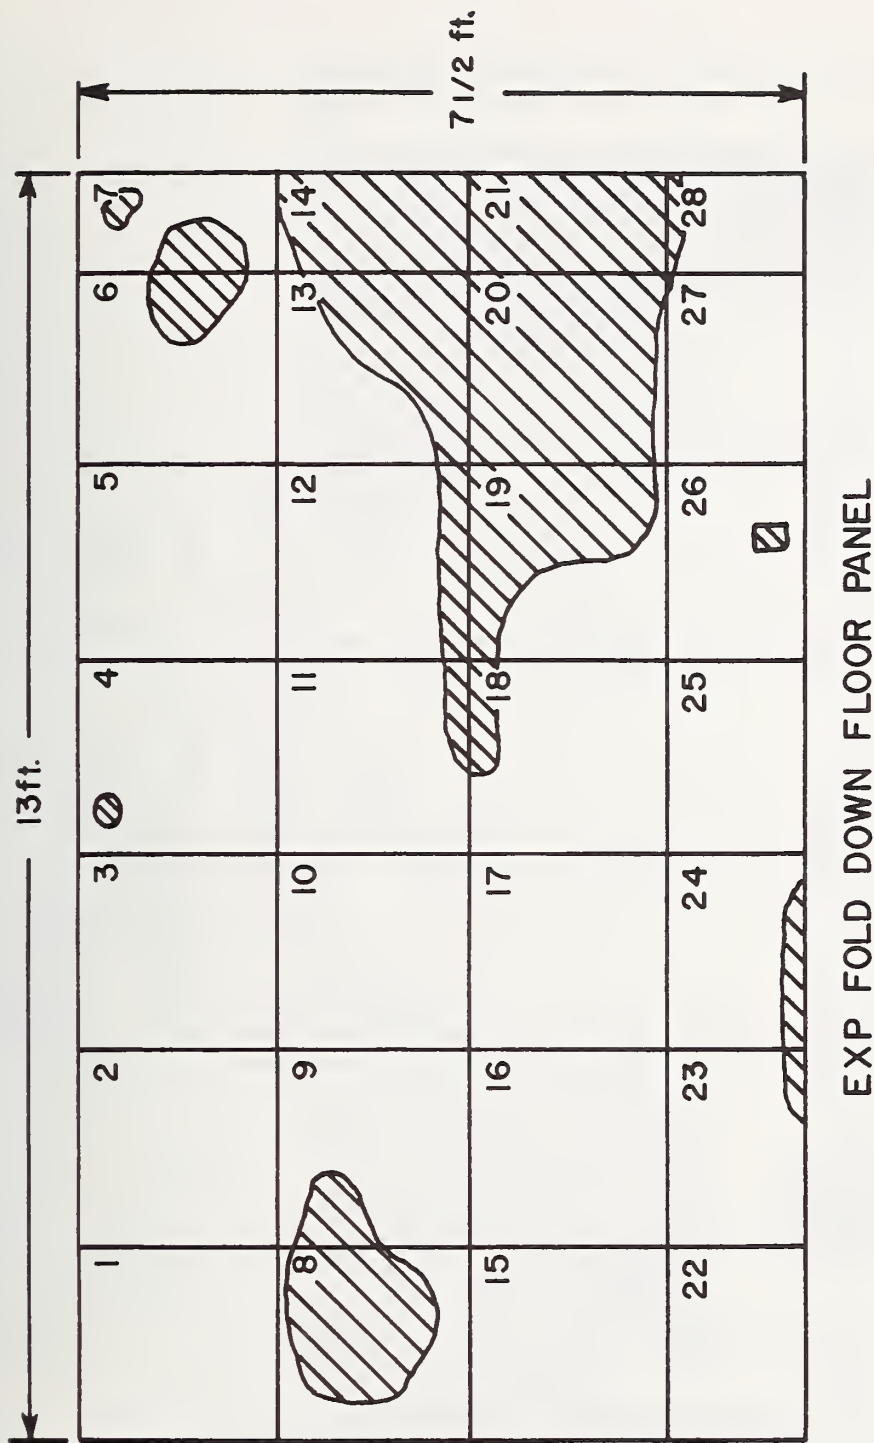
It should be pointed out that portions of the mid-height splices in the exterior facings of the 14R and 14L floor panels were loose so that water could penetrate. Major delaminations were found near these loose splices, especially below the splice (figure 3.7 and 3.8). From these two figures it appears that the upper corners of these panels were also vulnerable to delamination. Only minor delaminations were found on the center-structure panels, as indicated on figure 3.9, although the delamination at the bottom of the front panel (Panel No. 1) might have caused structural problems if the shelter had been dropped.

Fig. 3.7 Delaminations of exterior facing  
on EXP Panel 14 R

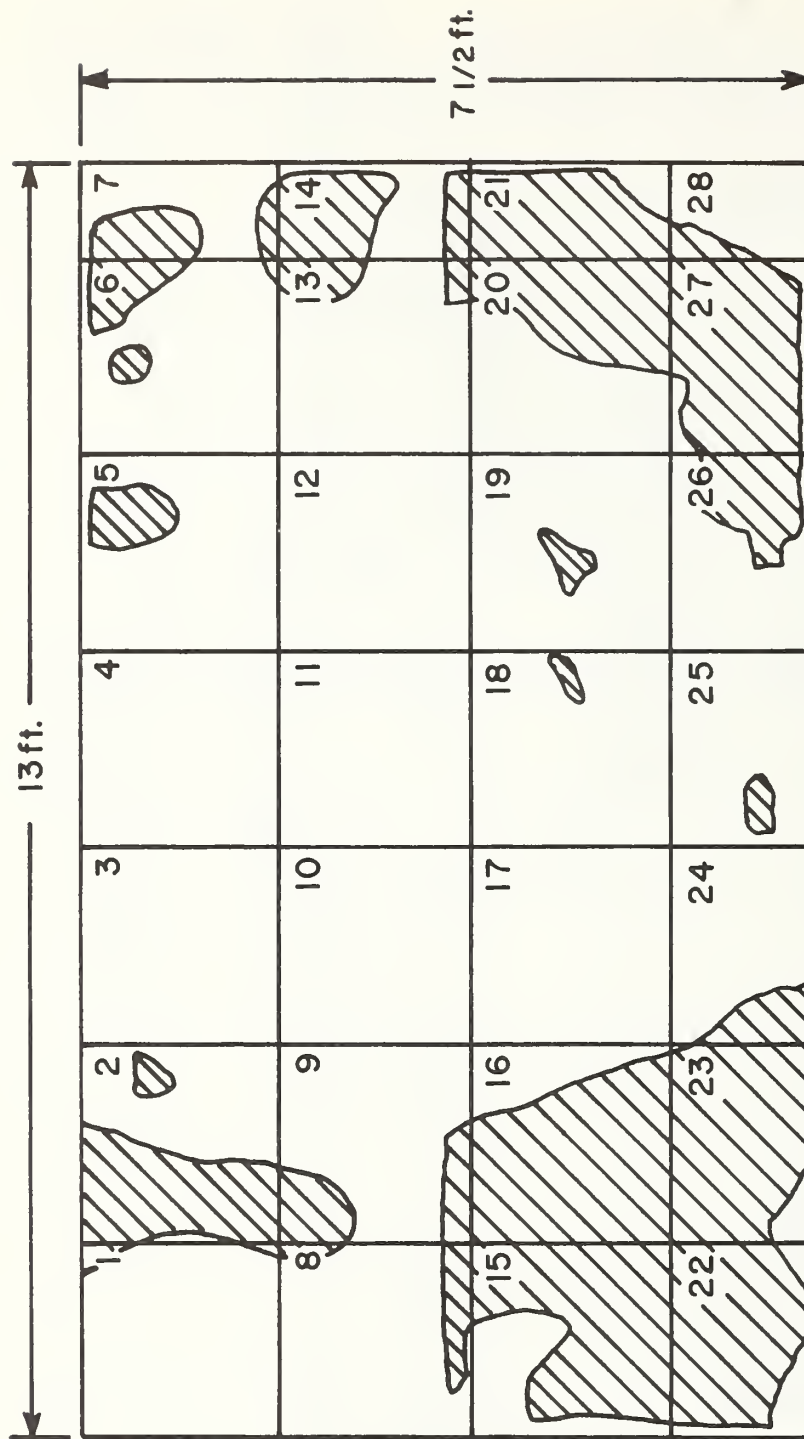
Fig. 3.8 Delaminations of exterior facing  
on EXP Panel 14 L

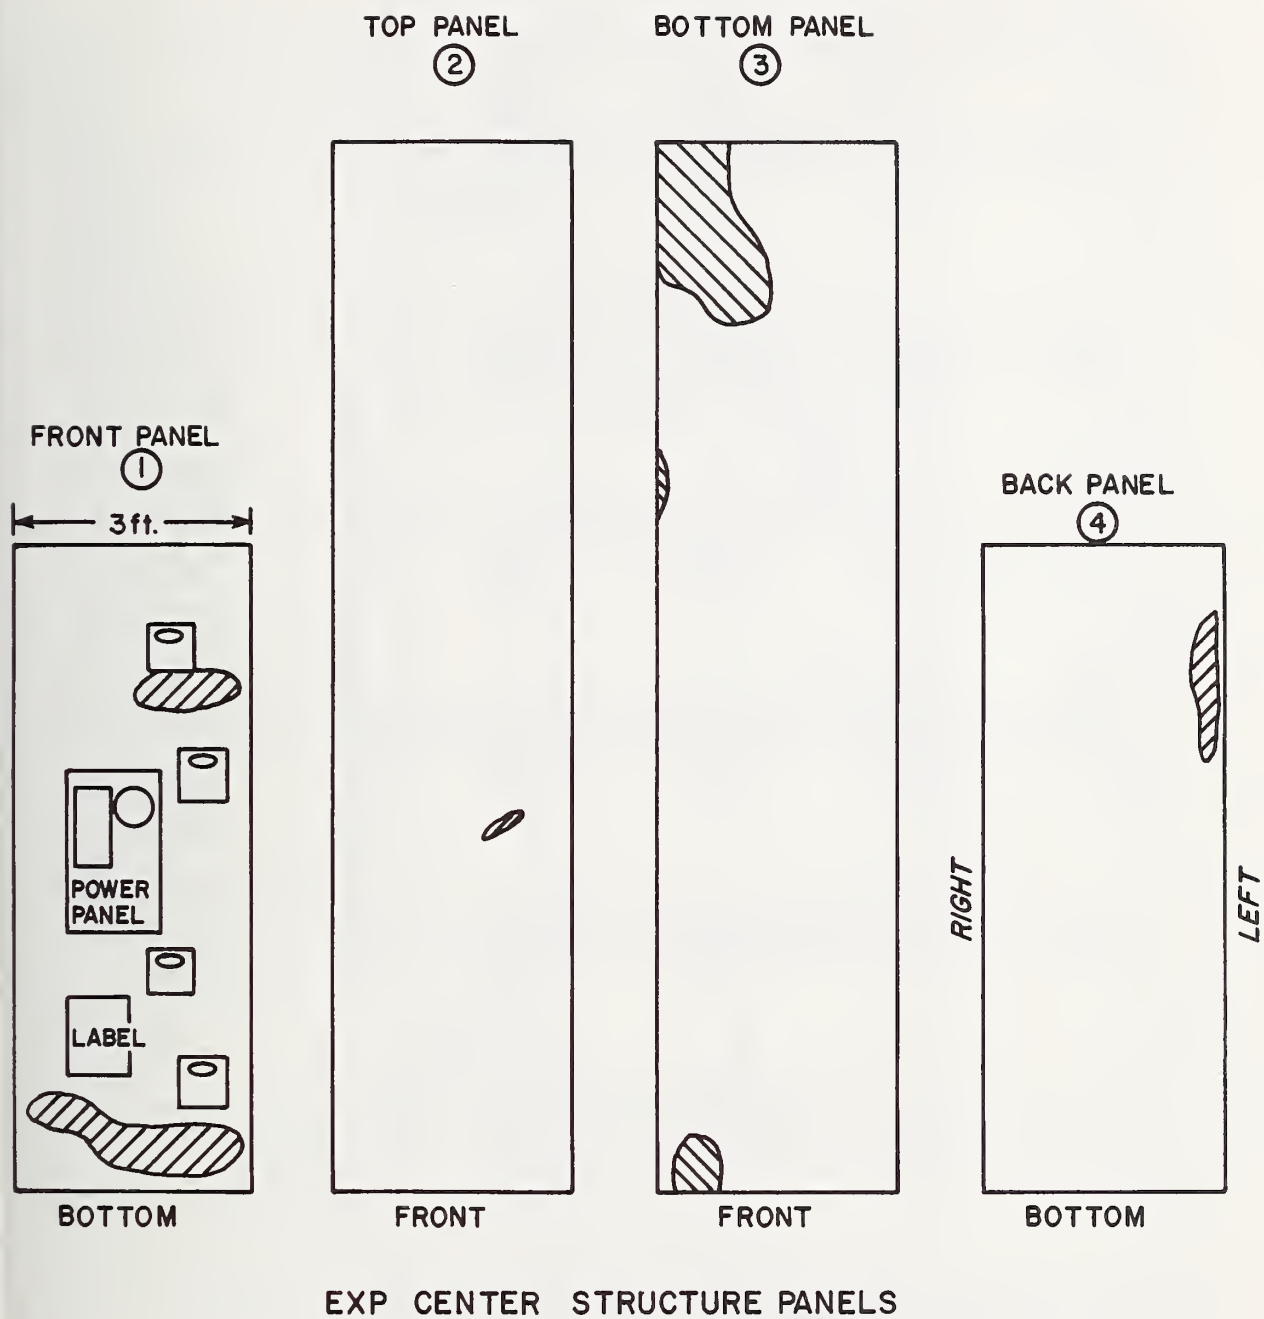
Fig. 3.9 Delaminations of exterior facings on EXP center-structure panels
